# Engineering Geological and Geotechnical Challenges of Lin Ma Hang Mine Revitalization – A Unique Community-based Educational Mining Heritage Project

*Meinhardt Infrastructure and Environment Ltd.*

*Geotechnical Engineering Office, Civil Engineering and Development Department*

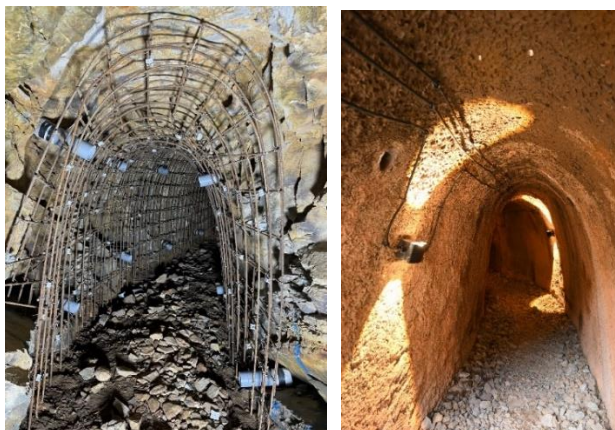
Figure 3: Paving wire mesh prior to shotcreting in Adit A6B (Left); Lighting on the shotcrete lining added after works (Right)

Dentition was proposed to support a localized rock block on the western wall of the adit to mitigate risk of structural controlled minor rock block failure. For a 12m portion, 100mm shotcrete with 2 layers of A252 mesh (Figure 3) was proposed to mitigate the stress due to shallow rock cover and localized fractured rock.

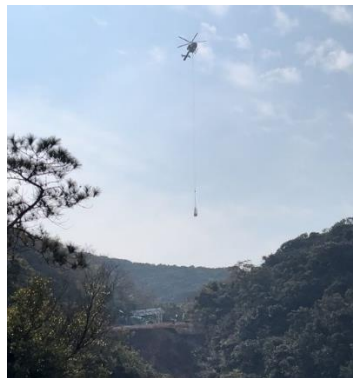
Figure 4: Helicopter Lift in Operation

The remote and undeveloped nature of the site resulted in logistical challenges. The site is at +181mPD with access limited to a hiking trail of "998 steps" without vehicular access. This posed enormous difficulties for manual lifting methods as a means to transport material to the site. Therefore, material delivery was limited to airlift, requiring advanced planning and coordination between the site supervision team and the contractor (Figure 4).

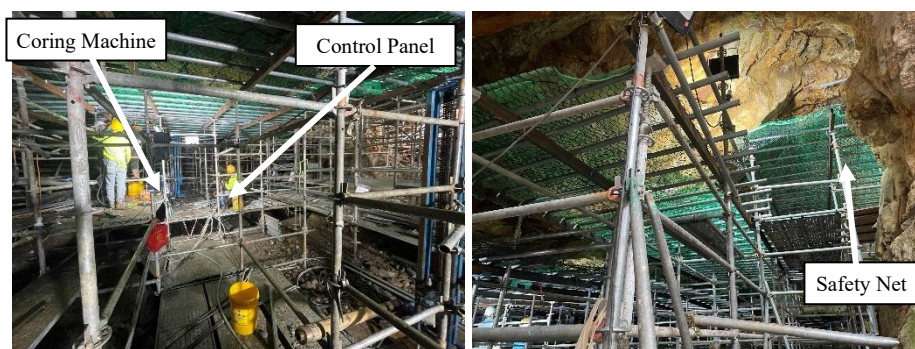
Figure 5: Coring Works - Scaffolding platform with safety net to prevent rockfall

The majority of the geotechnical works are confined to the main cavern and atrium area, situated in proximity to a SSSI for one of the most important bat roosts in Hong Kong (Wong et al., 2004). The Site Team planned and conducted works to minimize disturbance to bats, particularly during the breeding season, through control of work procedures and programming of work fronts. Typical coring works present noise and dust issues. Therefore, an electrical coring machine with water flushing was utilized within the operational area enclosed by tarpaulin sheeting to reduce noise reflection and spread of dust. Noise enclosure was used at the front of the coring machine to reduce dust emission. As the main cavern remained unsupported during construction, a safety net and lifting jet were deployed to prevent rock falling triggered by the coring works. Handheld tools were used to scale loose material and unstable rock fragments to reduce the risk of falls. Figure 5 illustrates the set up during the coring works.

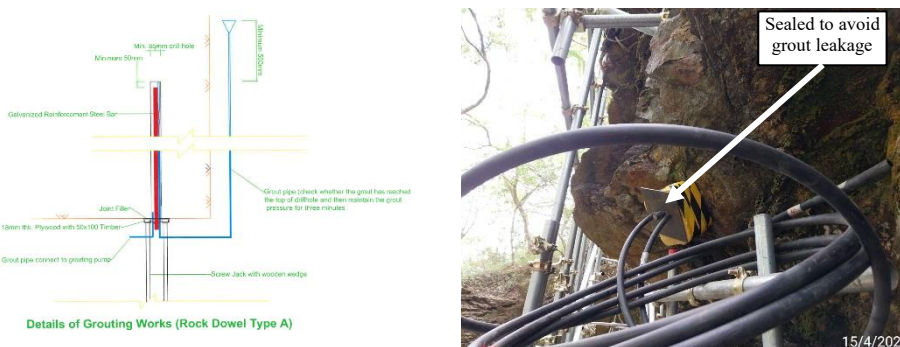
Figure 6: Details of grouting works (Left); Site photos of grouting of dowels (Right)

Innovative method using multi-stage grouting was preferred by first developing a grout fan above the crown, utilizing more diluted grout because of better penetration capability in the rock mass. As the cracks and joints were sealed, more viscous grout was used to fully grout the dowels. Figure 6 illustrates the setup for grouting. All the grouting works utilized the cored hole for the rock dowels and any leakage was immediately cleaned to avoid damage to the adjacent mine area. To check integrity of the grout inside the drillhole, the set up illustrated in Figure 6 was used. When the dowel was fully grouted, the grout pressure would drive the grout up along the pipe and reach the end for verification. Grouting terminated only when the inflow rate was equivalent to the outflow rate of the grout, allowing grout leakage to be checked indirectly.

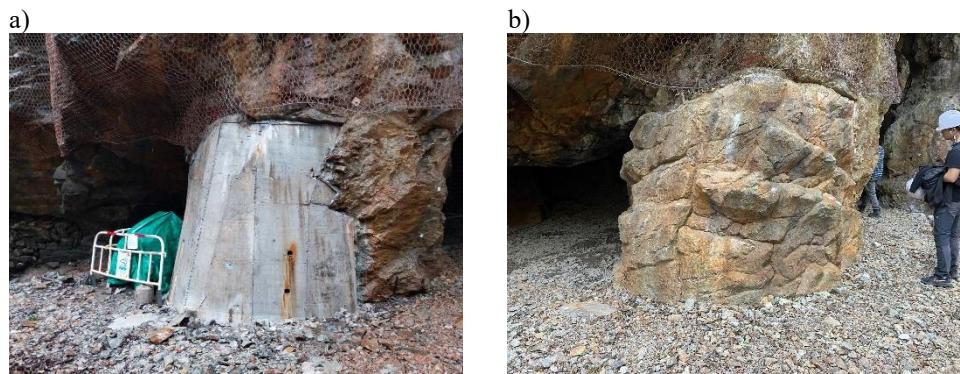
Figure 9a: Buttress B1 - (a) before artificial rock cladding fixed on concrete surface; (b) after artificial rock cladding over concrete surface

Figure 9a-9c shows a buttress before and after cladding. This is a unique example in Hong Kong demonstrating integration of mitigation measures to mimic the original landscape with a goal of heritage preservation and geotechnical safety both achieved.

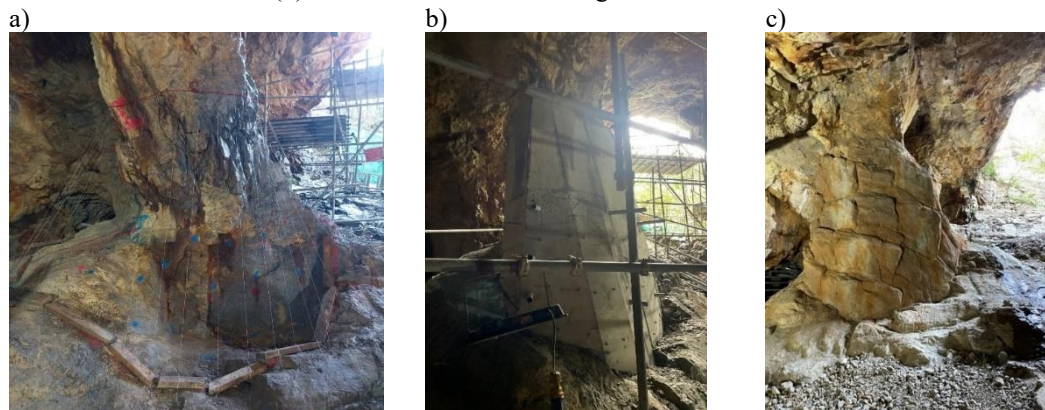
Figure 9b: Buttress B2 (Pillar P3) – (a) rock spalling as recorded during setting out the buttress extent; (b) before artificial rock cladding fixed on concrete surface; (c) after artificial rock cladding

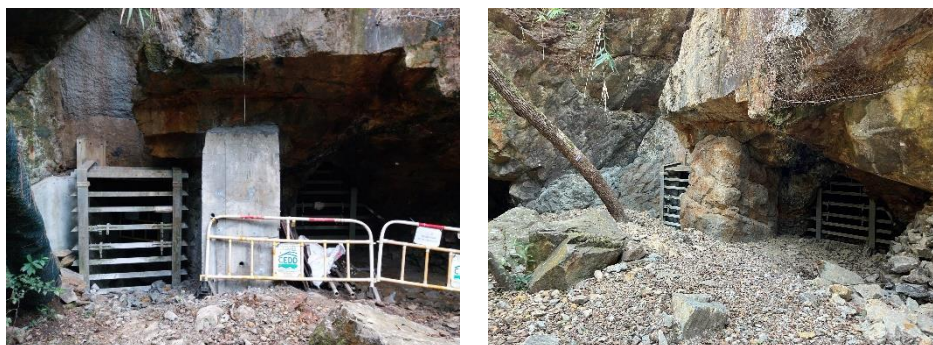
Figure 9c: Buttress B3 - (a) before artificial rock cladding fixed on concrete surface; (b) after artificial rock cladding

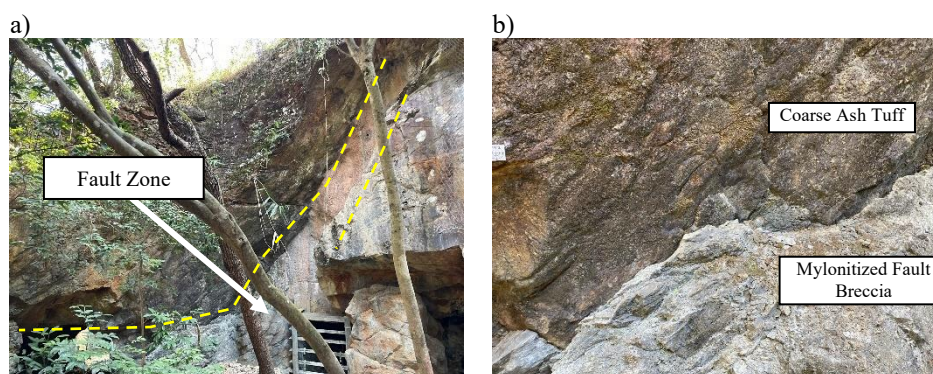
Figure 10: Geological Features of Special Interest in the atrium - (a) Fault Zone exposed in the atrium; (b) mylonitized fault breccia preserved at Entrance to Adit A6B as a geological feature of special interest showing results of crushing in a fault zone

The eastern end of the atrium at the entrance to Adit A6B exhibits a unique example of a geological feature of special interest – mylonitized fault zone striking into the atrium and main cavern. Whilst it was necessary to apply some protection measures to the fault zone, the design tried to retain the unique nature of the original geological feature without full shotcreting or wire meshing that a section of the mylonitized fault breccia was preserved without facing (Figure 10a & 10b).
